PRESERVATION OF HISTORIC STEEL BRIDGES IN VIEW OF ALTERNATIVE USE

Philippe Van Bogaert

Civil Engineering Department, Ghent University (Belgium)

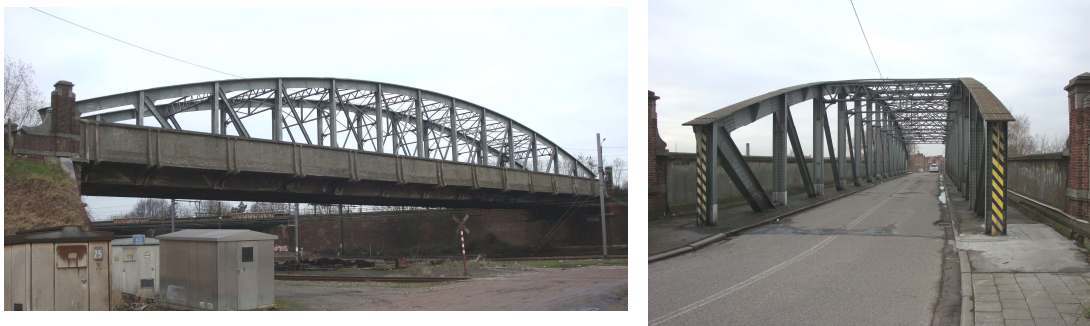
Fig. 1. Truss bridge of 60 m span

Obviously, the concrete parapets, to prevent electrocution by overhead lines, obstruct the view on part of the structure. In the view from the road (right of Fig. 1) the structural lines can be seen more clearly. The number of this type of bridges in Belgium is decreasing rapidly and this is one of the rare specimens left. This bridge was built in 1906 from early age steel and is completely riveted.

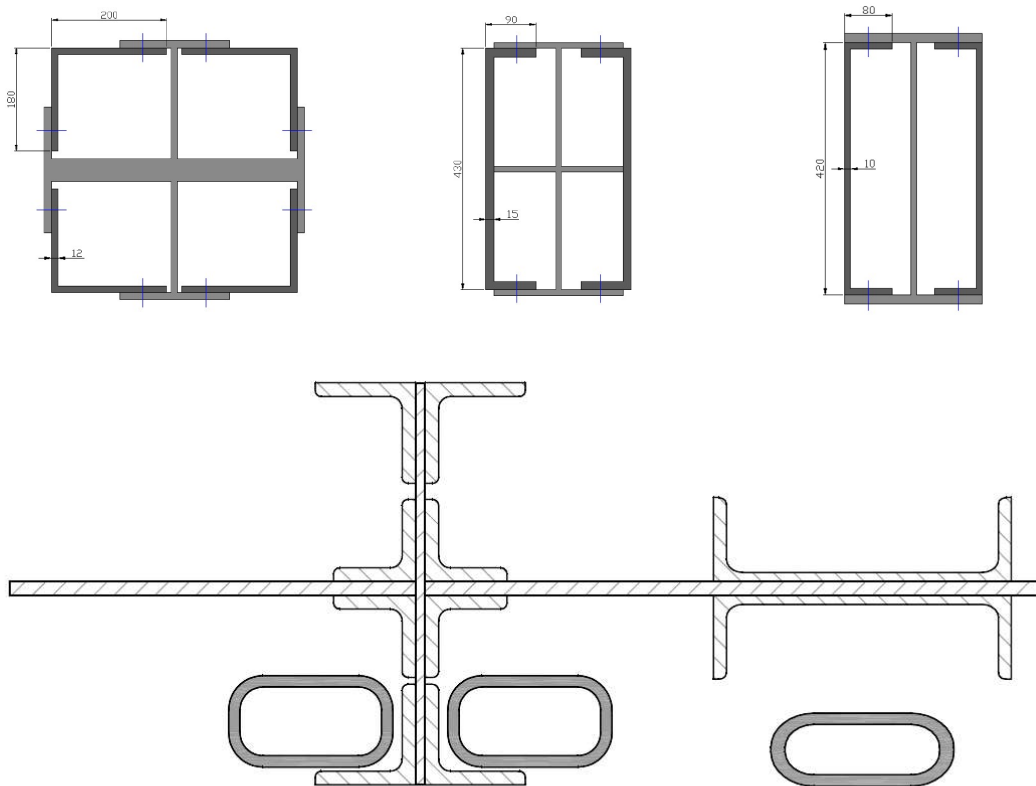
Fig. 3 :Reinforced cross sections

The first method would be to reinforce members by adding several profiles, mostly by closing open member sections. The riveted joints are to be replaced by tension controlled bolts. These have round heads on one side and thus, from one side, are resembling rivet heads. Cross sections would become as shown in Fig. 3 top. However, this is considered to be a hazardous method. The alternative is to build completely independent welded lightweight truss RHS girders of S 460 grade steel inside the hollow spaces of the various members. This requires replacing of the corroded crossbeams. This, from the outside (left of Fig. 1) the view has unchanged and even from the inside only small new parts will be visible. In addition the much too heavy upper bracing may be replaced by a simple connection of a closed section between the two new truss members. The old and new structure are to be connected by steel glue. This connection serves only to reduce the slenderness of the compressed members, thus giving a permanent function of stiffness without actual resistance to the existing trusses.

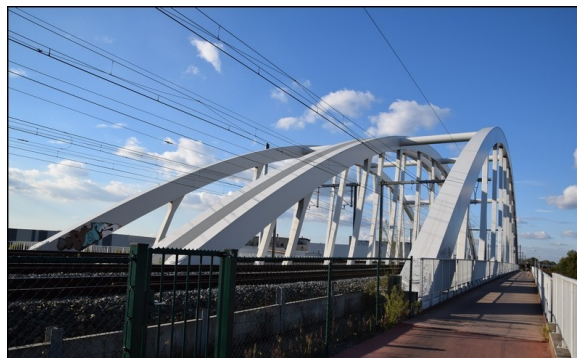
Fig. 4 :Corbelling cyclist path at crossing of river Nete

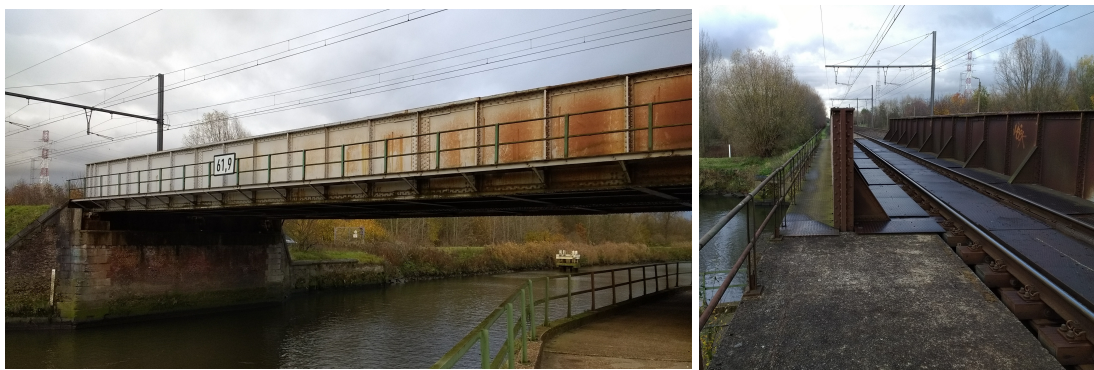
Fig. 5 shows this typical bridge, built of steel AE 235, the older name for the present S 235. This material has similar characteristics, but the variation of stress characteristics is wider and a more cautious value for f_{yd} must be adapted.

Fig. 5 :North and inside view on River Dender bridge near Oudegem

Closer views on parts of the bridge show at first sight rather serious corrosion. In addition, a problem seems to have occurred to the movable bearings. The latter certainly is outside the present discussion. For these reasons, the owner has put this bridge under reinforced surveillance. However, apart from local defects, presumably the appearance of the bridge is more worrying than the actual corrosion damage.

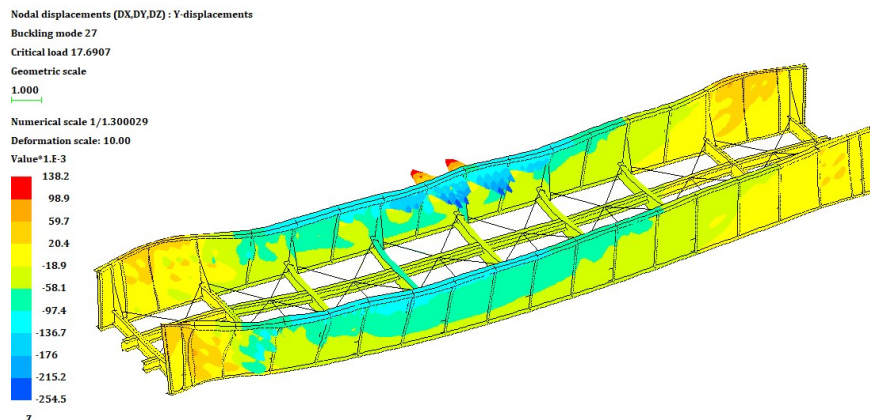
Apart from additional vertical load, adding the bicycle path introduces longitudinal torsion of the plated girder. The latter has but small torsional resistance, since this is provided by out of plane bending of the web and its vertical stiffeners. Hence, also lateral torsional buckling, as well as plate shear buckling have to be considered. As shown in Fig. 6, no clear lateral torsional stability mode is found, since it interacts with local plate buckling.

Fig. 6 : Lateral torsional buckling mode

In addition, the lateral torsional slenderness of 0.273 is below the limiting value of 0.4 and further influence of the stability mode does not have consequence on the stress magnitude. The analysis has shown that the corbelling cyclist path may increase the stress level with 40.7 % especially because of the skew of the upper flange of the closest plate girder. This effect is entirely due to the poor lateral resistance of this type of structure and could be expected right from the start. Although the unity-check of stress conditions in ULS is limited to 0.95, the project has been put on hold. In spite of its fundamental flaw, the owner seems not to be opposed to the project and has decided to inspect the structure more thoroughly, in view of determining possible deterioration due to corrosion. Plate and profile thickness are to be measured to further decide on the future of this project.
